Background

Lincoln Grove is a development of 9 x 2 and 3 bed homes near Woodstock, 9 miles from Oxford, constructed in 2007. The homes were awarded EcoHomes excellent, scoring 77 credits, the same as BedZED. The homes have been subsequently re-assessed under the Code for Sustainable Homes and achieved level 3

Primary Air Barrier — Design it with CARE

Bladon—Thermal Bridging

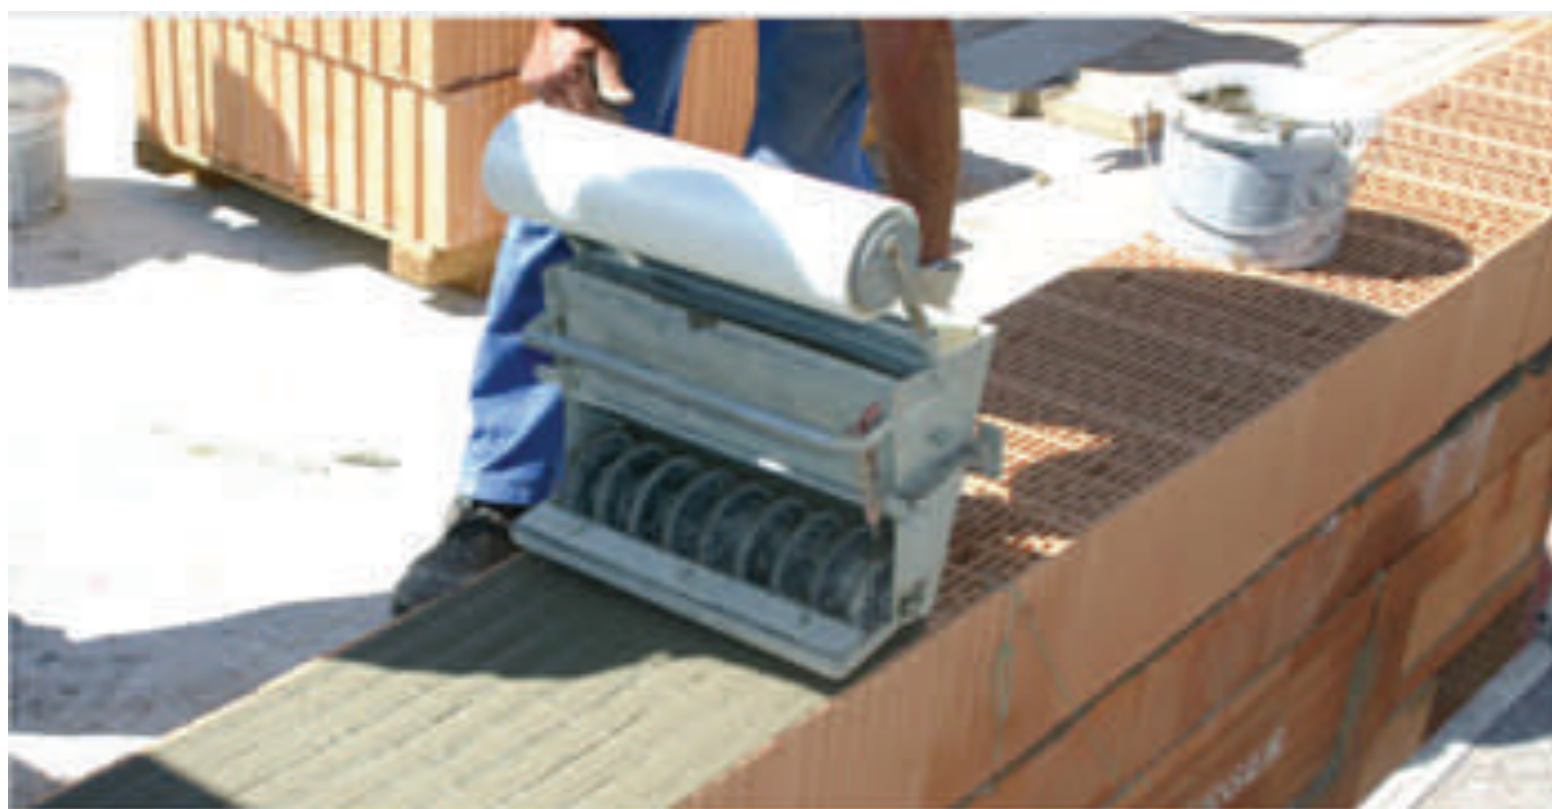
- Roof**: 300mm of Warmcell insulation blown in between 250 mm I-beam rafters with 35mm wood fibre insulating sarking board
- U-value: 0.11 kWh/m²k (0.15) y of 0.04
- Floor**: Concrete planks with 150mm Kingspan insulation under a 50mm screed with 50mm edge upstands;
- U-value: 0.12 kWh/m²k (0.20)
- Walls**: 365mm Thermoplan single skin cellular insulation monolithic clay blocks with stone or render facing
- U-value: 0.26 kWh/m²k (0.28) y = 0.05

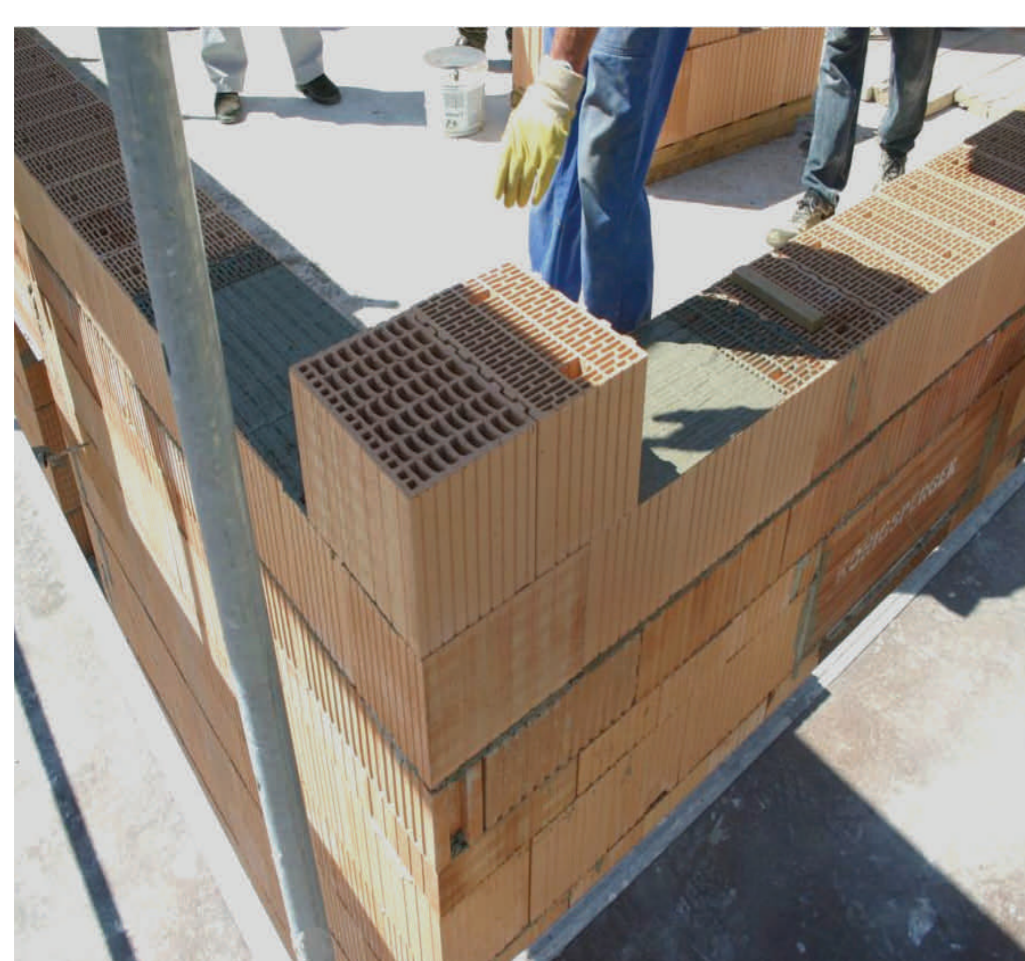
The roof is slated over low timber content I-beam rafters, supported by timber trusses and steel purlins. I-beam timber joists also form the first floor. Warmcel recycled insulation is used throughout the roof and first floor.

Careful attention was given to selection and use of a complete build system design that reduced thermal bridging to a minimum. Construction details using ThermoPlan were calculated to an exceptionally low y -value = 0.024

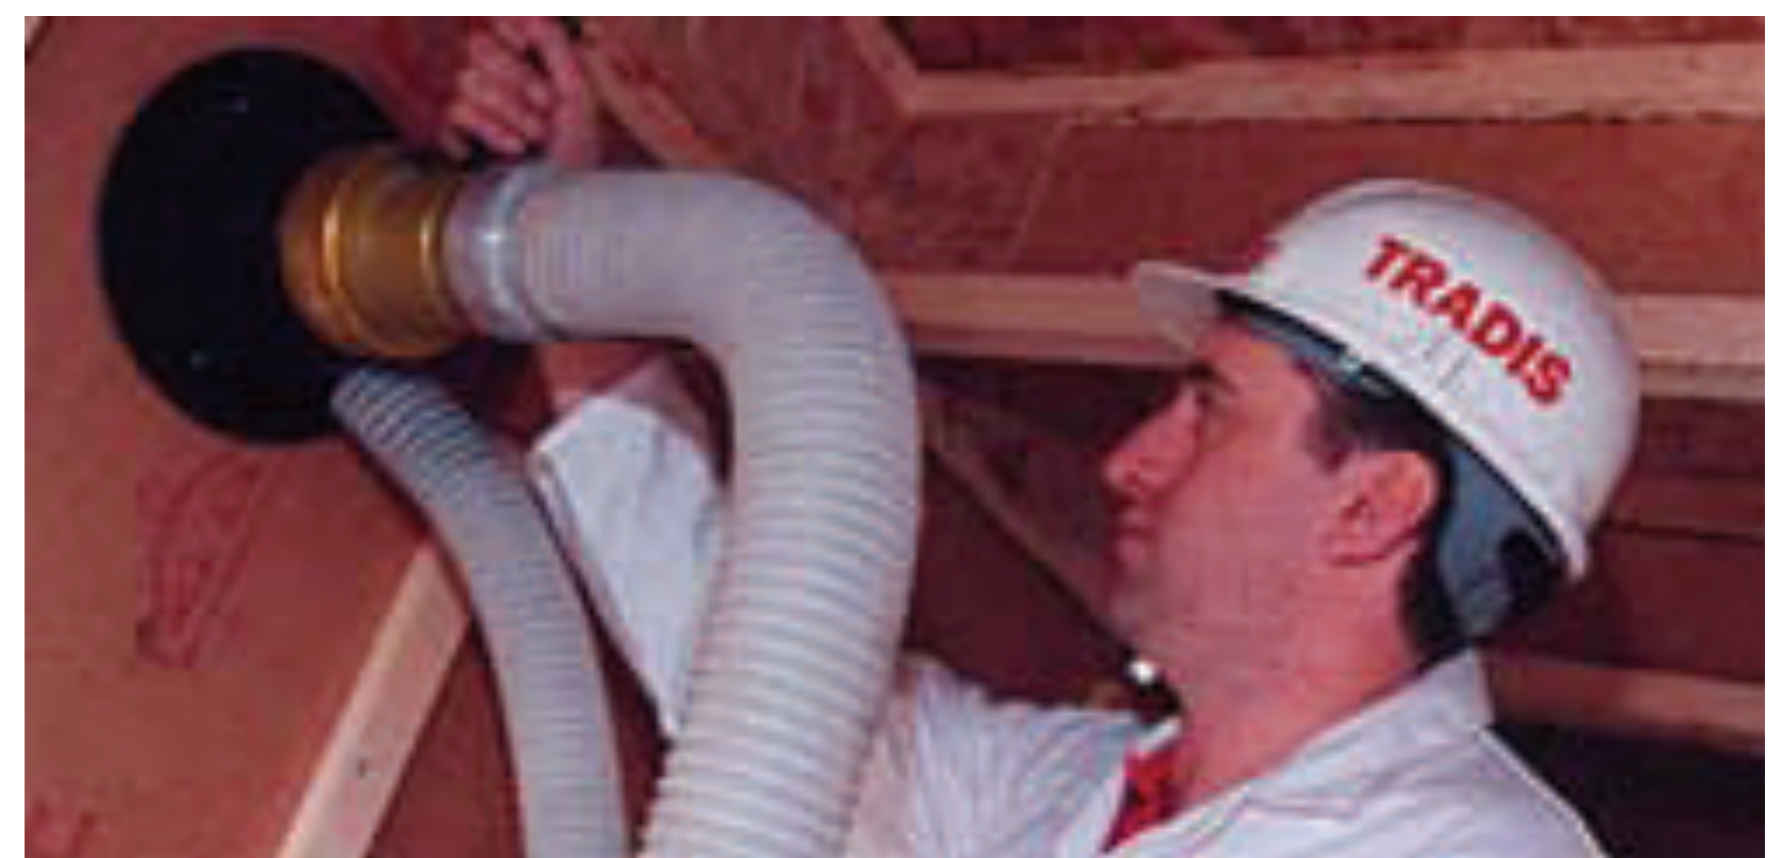
Junctions with steels were carefully detailed and extra insulation around the joints - included – thermal breaks

The timber I beam rafters also reduce thermal bridging as the web reduces the flow of heat

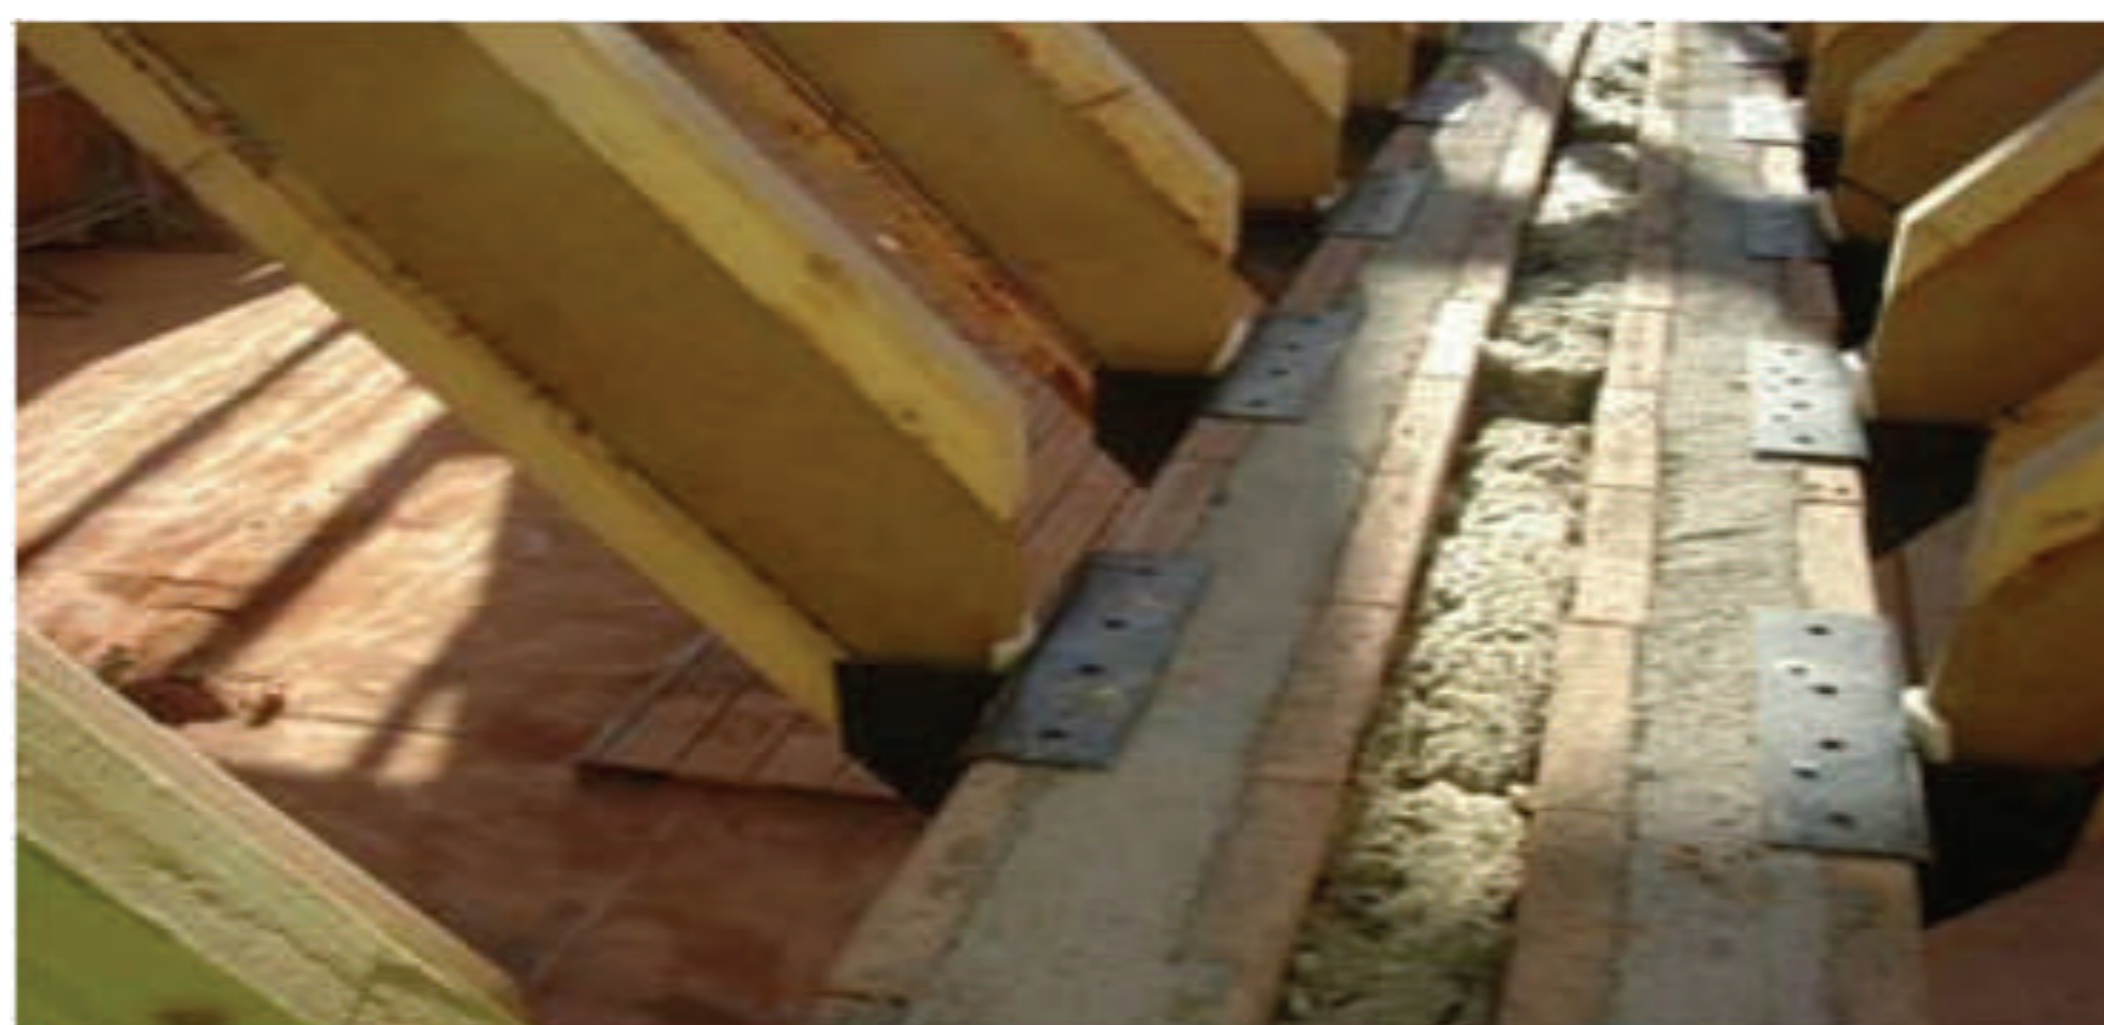
Type 2: Air Movement Within and Around Insulation

The use of the Thermoplan system meant that this problem was removed from the walls. Warmcel 500 was used in the roof and the advantage of this product is that it is blown in under pressure and fills any gaps and cracks, thus reducing any thermal bypassing.

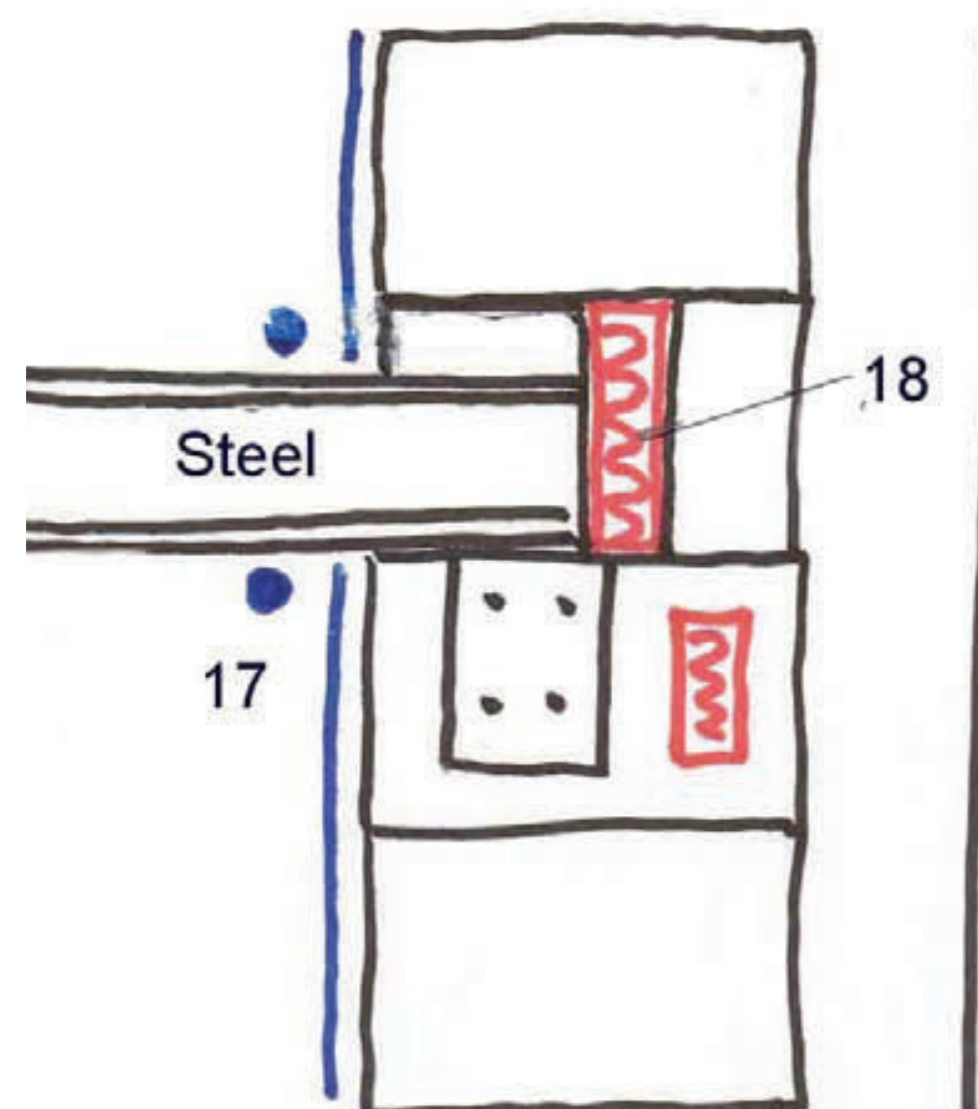
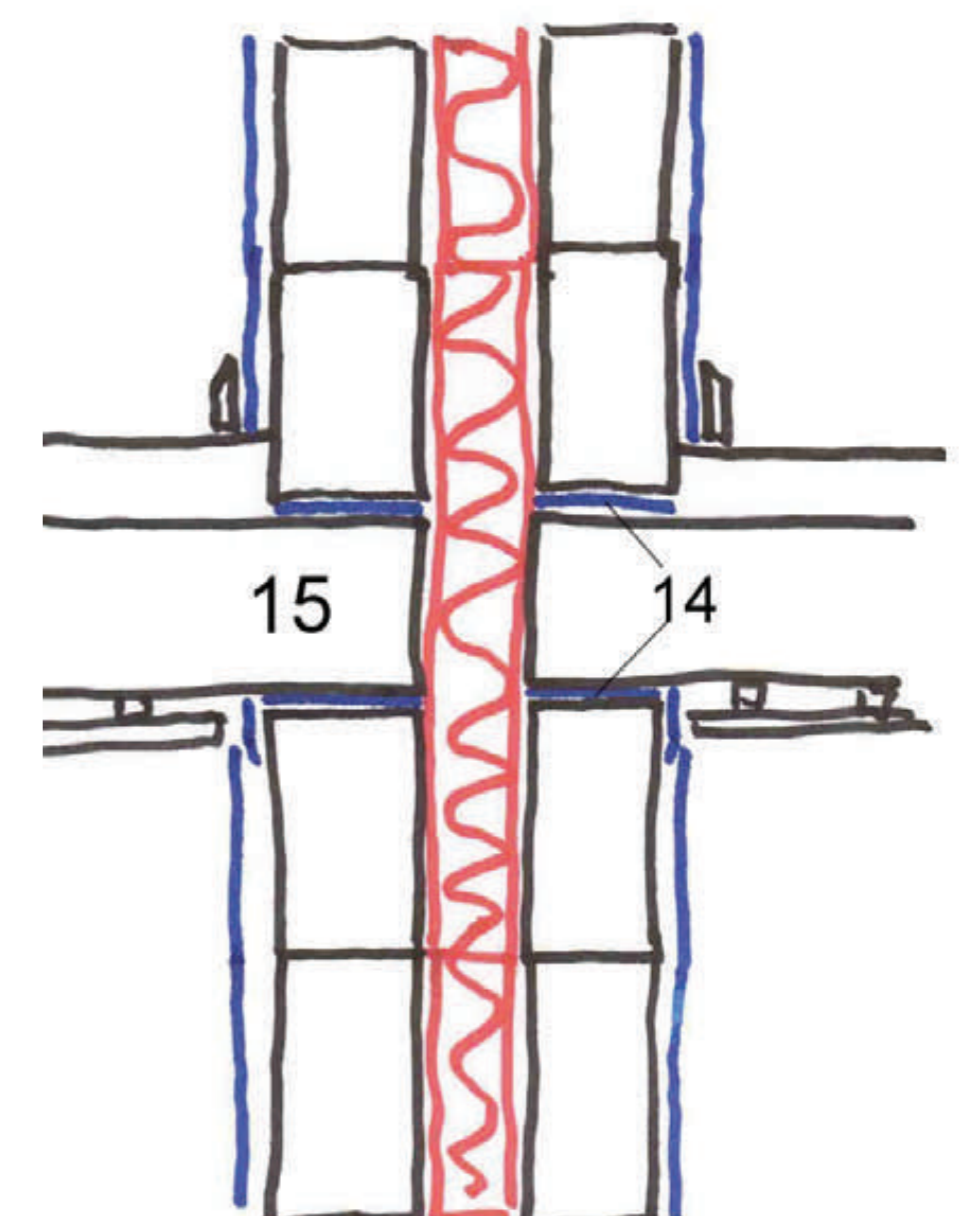
First Floor Plank bearing

14. Ensure fully filled bearing top and bottom for air seal (D,E)
15. Check perps for planks filled especially in built in ends (D,E)
16. Check Insulation strip on external walls on end of plank (D)

17. Check pads correct height and insulation block in lintel block (F)
18. Check insulation correctly placed at end of beam (F)
