Good Homes Alliance Monitoring Programme 2009-11: Technical Report

Results from Phase 1: Post-construction testing of a sample of highly sustainable new homes

**Results from Phase 1: post-construction
performance of a sample of highly sustainable
new homes**

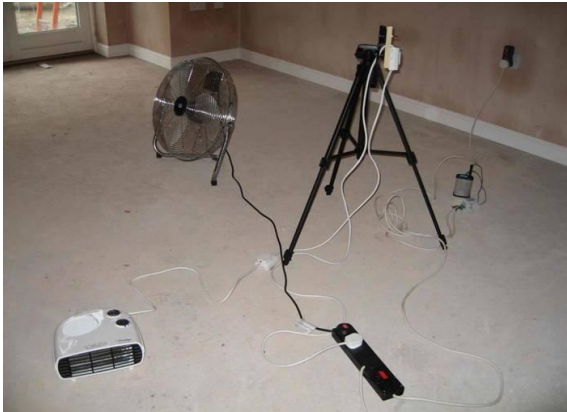
Figure 1: Co-heating test equipment; photograph courtesy Leeds Metropolitan University

The co-heating test is designed only to measure the heat loss through the fabric of a building. Although a background ventilation test is conducted immediately before and after the co-heating test, this is done simply to eliminate the natural background ventilation heat loss from the dwelling, so that this can be separated from the fabric heat loss.

The co-heating utilises a tracer gas decay method to confirm the background ventilation rate during the period of the co-heating test. In this, a gas (usually CO₂) is dispensed into the sealed building once daily, and sensors around the dwelling measure the gas concentration over time to determine the amount of gas that has leaked out. Further details of the methodology for co-heating tests are available at Wingfield et al.¹¹

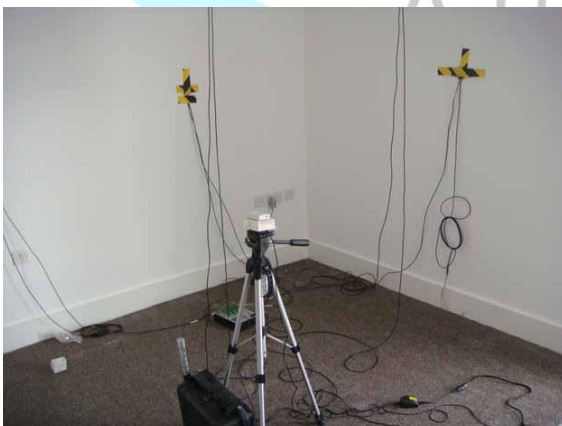
Figure 2: Heat flux sensors; photograph courtesy University College London

The insulation performance of solid elements, such as a wall or a roof, can be measured using local heat flux sensors (see figure 7 below); these measure direct heat flow through various elements of the building fabric. The measurements are used to determine an effective average U-value for each element concerned, and the information can be used to help identify any areas of heat loss from a dwelling.

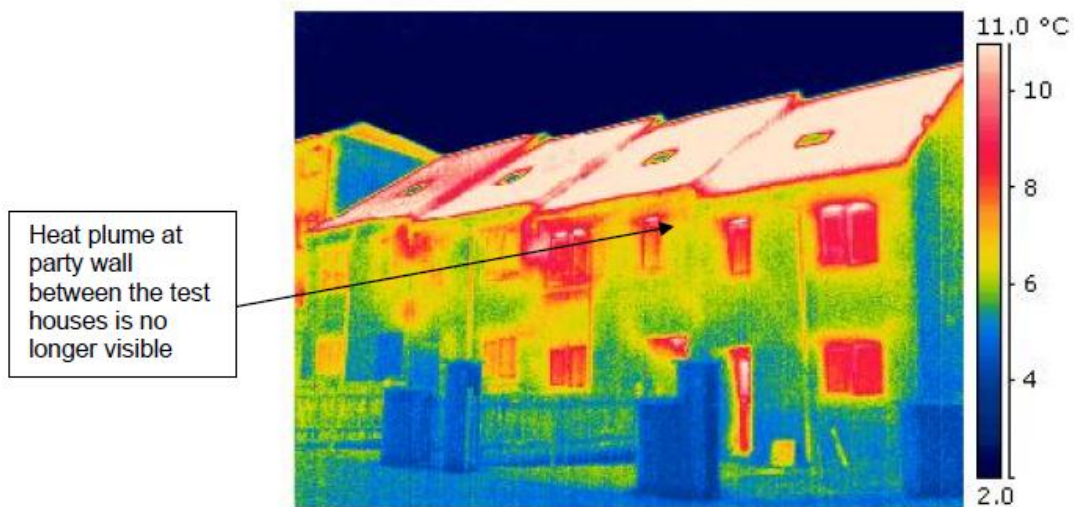
Figure 4: Infra-red Thermal Image of Terrace containing Test House after filling, (Wingfield, J., et al, 2010⁹)

Figure 4 below shows an Infra-red thermal image taken after the party wall cavity between the test houses has been filled with insulation. This shows that the heat plume due to the thermal bypass was no longer visible at the party wall between the test houses but that the plumes were still present in the other houses in the terrace where the party wall cavities remained empty.

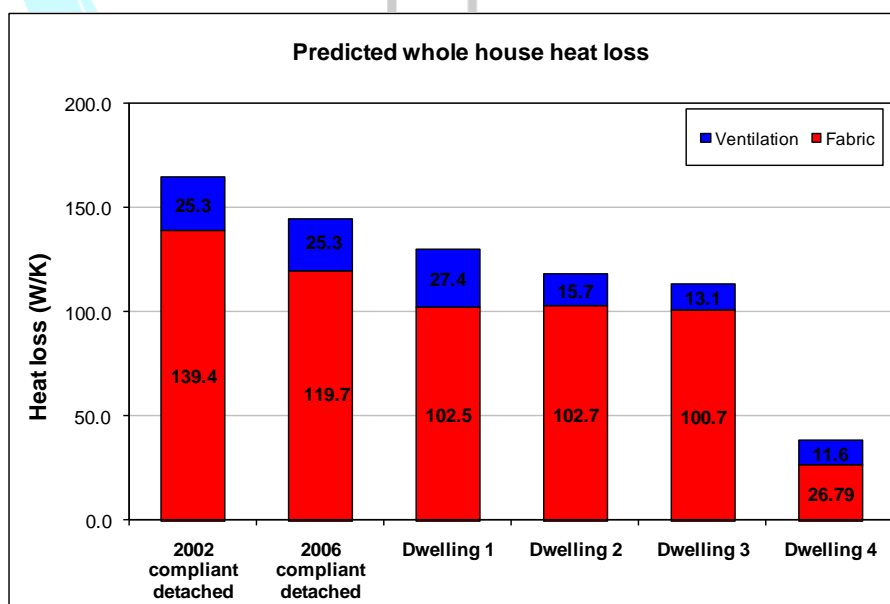
Figure 5 – Predicted whole house heat loss of the test dwellings compared to building regulatory requirements¹⁷.

Note: results for 2002 and 2006 compliant properties are based on SAP calculations using a 2 storey detached house with Gross Floor Area of 105m².

The predicted fabric heat loss values, in table 2 were taken from the SAP worksheet supplied by the house builders. The predicted ventilation heat loss figure is actually calculated from the pressurisation tests used during the monitoring process, as it cannot be predicted using SAP. The predicted ventilation heat loss is then added to the predicted fabric heat loss to obtain a predicted whole house heat loss.

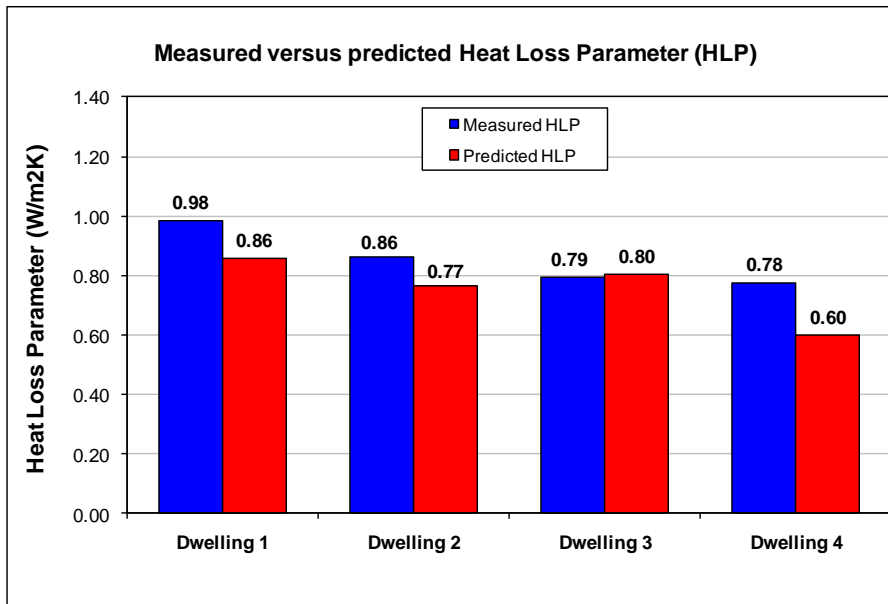
Figure 9. Measured versus predicted Heat Loss Parameter for the GHA-tested dwellings. [Johnston, D., 2011¹⁸].

Whole house heat loss is very dependent on dwelling size and built form, as described previously, so comparison of the heat loss parameter for each dwelling is more useful, see figure 9 below. This illustrates that the test properties tested varied considerably in terms of their predicted and measured heat loss parameter.

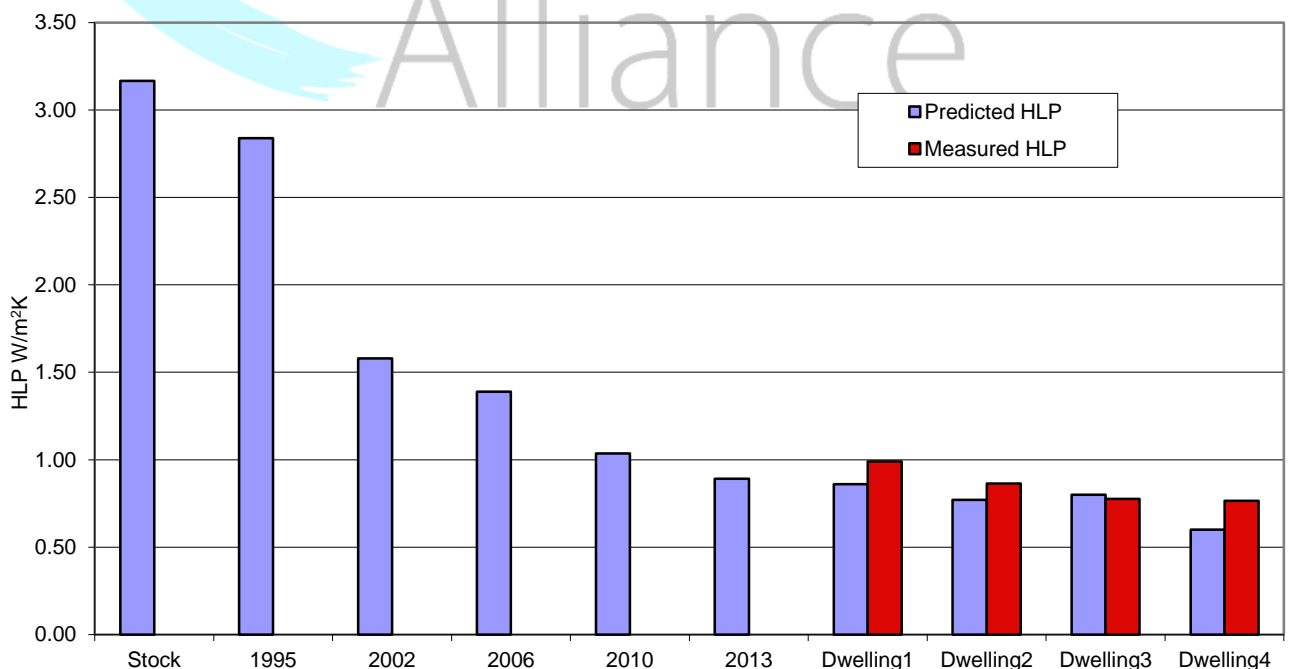
Figure 10. Measured heat loss parameter of the GHA test properties, compared to the stock, past, present and predicted building regulatory requirements. [Ridley, I., 2011¹⁷].

The results of the measured fabric performance of the test properties are favourable in comparison to the heat loss parameter for a notional semi-detached dwelling that complies with Building Regulations Part L1A 2006 (see figure 10 below).

It is worth noting that each dwelling should be expected to perform better than the Building Regulations Part L1A 2010 target, as each was designed to a lower target than that in the first place. However, given the poor performance evidenced in other research (see section 4.3.4), the success of these schemes should still be celebrated.

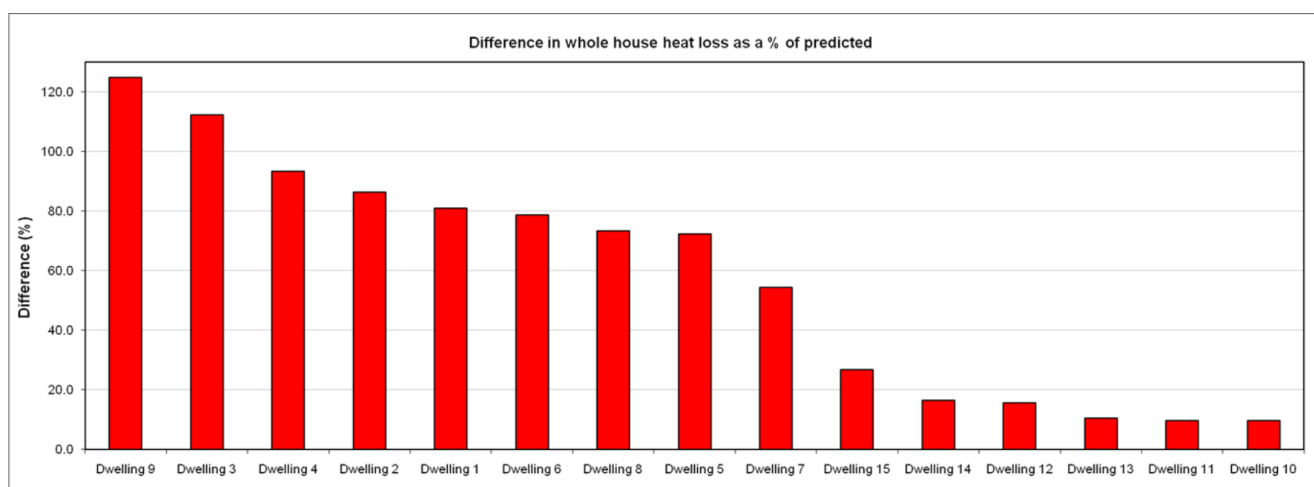
Figure 12. Difference in Whole House Heat loss as a % of predicted.⁷

reported that the gap between predicted and measured heat loss of the homes they tested can be over 100% (see figure 12).

Note that the dwellings in figures 11 and 12 relate to those tested by others and do not show the results of the GHA-tested homes.
